# WATER PLANT OPTIMIZATION STUDY HAMILTON WATER TREATMENT PLANT

**JANUARY 1994**

Ministry of Environment and Energy

#### Pollutech Environmental Limited

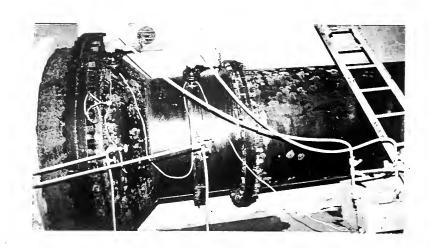
VENTURI FLOW METER

The flow measurements from the raw water venturis are questionable since neither meter was installed according to standard practices. A standard venturi tube consists of a reduction in pipe diameter, a section of constant pipe size, followed by an enlargement to the original pipe size. Sections of straight, uninterrupted pipe (calming links) are necessary both upstream and downstream of the venturi.

In both Modules 1 and 2, the venturis are followed closely by main flow control butterfly valves. When these valves are completely or partially open the valve plate would interfere with the measurement of flow through the venturi. Also, both venturis 1 and 2 lack the standard calming links upstream and downstream. In Module 2 the flow is measured through a reduction in pipe diameter (1830 mm to 1220 mm) but there is not an enlargement to the original pipe size.)

A flow calibration of these venturi would be necessary to test the accuracy of the measurements. The differential head is checked and calibrated annually by Maintenance Department staff, but the actual flow as it relates to this differential is not calibrated.

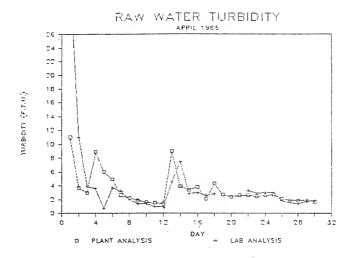
FIGURE 9 (cont'd)

The turbidity of the raw water is measured and reported at two locations. The laboratory staff takes turbidity readings and records them on the daily laboratory sheets. The turbidity is also measured at the water plant and a daily average is reported on the plant's monthly report. The raw water turbidity values from the two sources vary. The raw water used by the laboratory for their analyses comes from the water plant via a sample line several hundred meters in length. Although water is running through the pipe at all times, some changes in the water quality may take place within the sample line. The graphs in Figure 9 show this variance in turbidity values. This may be due to one or more of: water quality changes in the sample line, sampling at different hours, a difference in the calibration and/or operation of the turbidimeters. The difference in magnitude of the two means is usually all (less than 2 NTU), but because the values are also low, the difference is noticeable. For consistency, the comparison of turbidity made in this section will be using the plant raw turbidity data since these are the values available to the plant staff when they set the alum dose.

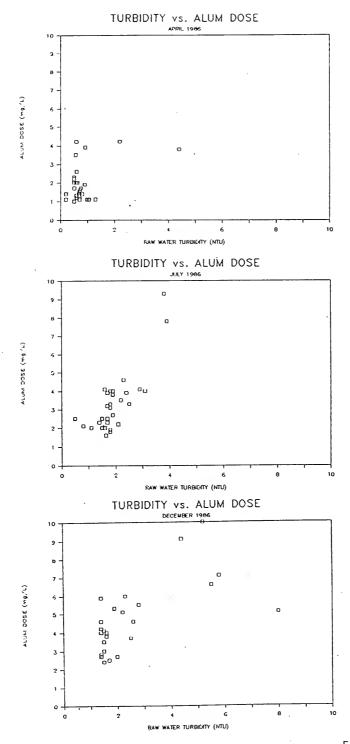
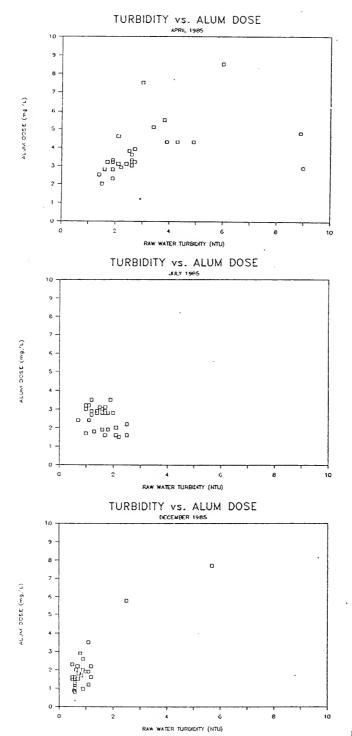
FIGURE 11
Turbidity vs. Alum

The alum dose versus the turbidity was not consistent; this is illustrated by the graphs in Figure 11. The operators base their selection of the alum dose on the turbidity reading and on their experience. In the past two or three years the use of alum has become more conservative, according to Walter Furry. The operators now try to achieve the best possible finished water using the minimum amount of alum. It should be noted that the alum dose calculation is based on the flow of raw water as measured by the venturi meters. Since the accuracy of these flow measurements is questionable, the reported alum dose may also be inaccurate.

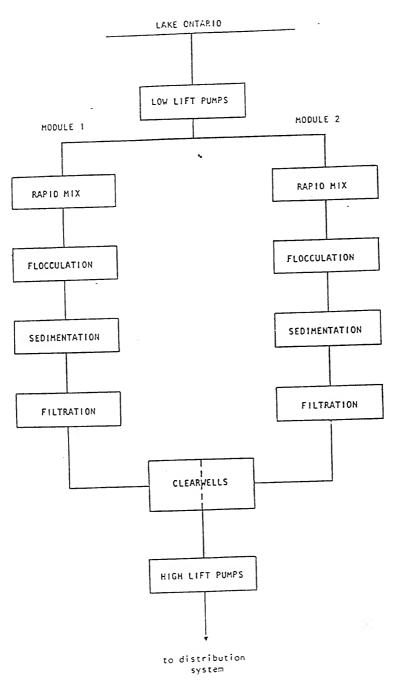
FIGURE 1 Process Block Schematic

The Hamilton-Wentworth Water Treatment Plant is a conventional facility utilizing coagulation, sedimentation and filtration. Figure 1 is a schematic of the treatment processes. It is a large plant, treating an average of approximately 300,000 m³/d and serving a population of 385,000. To save on hydro costs, the plant operates only at night Monday to Friday and 24 hours per day from Friday night to Monday morning.
